WEEKLY CONSTRUCTION INSPECTION REPORT

Report 04
Project: Location: Contractor: Client: From: To:	Northeast Harbor (Northeast Harbor RF Jordan & Sons Town of Mount De Victor J. Smith, P.F. Tony Smith, Direct	sert =.		s D	ate: 5/6/19
WORK COM	PLETED THIS WEE	K:	(W/E) 5/4/19		
Hardware. Test pitted the into the second Test pitted the Cut over the 6-line is now aba	sewer on Summit and dary line to be aband flushing sewer mank-inch sewer into the andoned and will be	nd determin doned in pla hole on Mai existing sev filled this fal	ned the location ace. in Street to deter ver manhole in f Il during sewer v	we for the fire service and that there were remine invers in and or ront of the first. The work.	no services out. remaining
<u>Manpower</u>					
RF Jordan &	Sons	6 days			
PROJECT ST	ATUS				
	Complete	Sched	uled Completior	Date	
	on schedule or		days/weeks	ahead/behind sched	lule
				completed Tuesday 5 it is not possible to de

JN: 10328.016

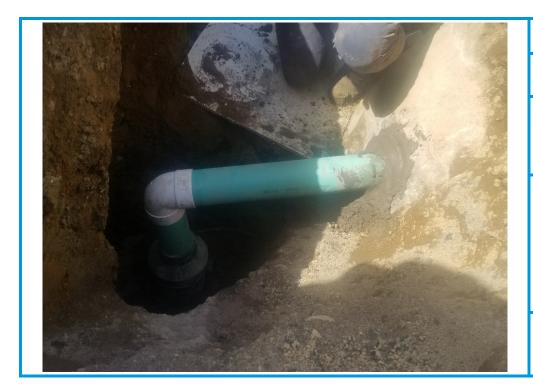
Photo No. 1

Flushing Sewer Manhole

Repair of the piping out of the flushing manhole on Main Street

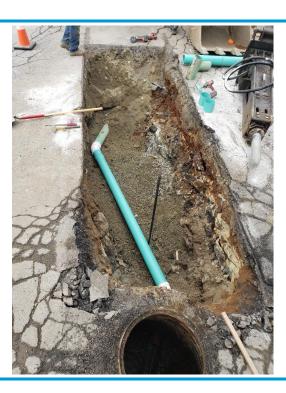
Photo No. 2

Sewer Manhole E4

Connection of the abandoned sewer line into the existing sewer manhole in front of the FIRST

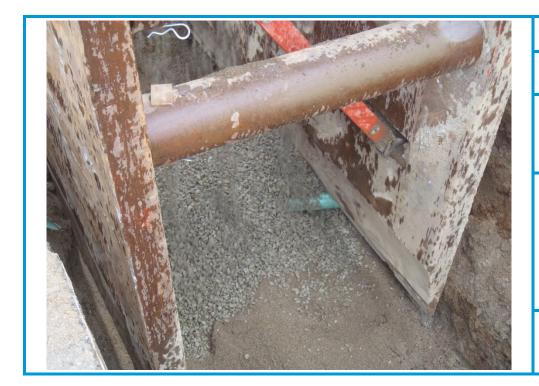
Photo No. 3

A 4-inch cast iron perimeter drain (??) extending into the street and connecting into the existing sewer (as near as we can tell) has caused us to reroute the new water line under it to allow it to be reconnected. The water line was dropped by digging back 40-feet and resetting the line lower to clear under the line. The line was then reconnected to maintain gravity flow. We could not determine whether this 4-inch line was sewer or not and where it originated from. It was flowing small amounts of water and there was no indication of sewage but the elevation of the pipe indicates that it connects into the Main Street sewer line and not the drainage system.

4-inch drain line reconnected over the 12-inch water main after it was dropped

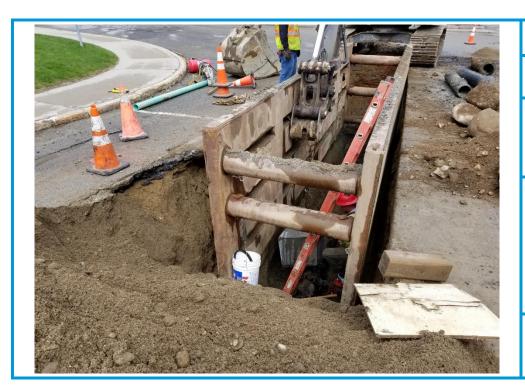
Photo No. 4

4-inch gate valve for the fire service into ACE Hardware
