WEEKLY CONSTRUCTION INSPECTION REPORT

Report 02
Project: Location: Contractor: Client: From: To:	Northeast Harbor Center Village Improvements Northeast Harbor RF Jordan & Sons Town of Mount Desert Victor J. Smith, P.E. Tony Smith, Director of Public Works				Date: 4/21/19
WORK COM	PLETED THIS WE	EK:	(W/E) 4	/20/19	
	emoved ledge in the on Main Street for er main pipe.			ation.	
3.0 Da	ys worked this wee	ek <u>0</u>	_ Day(s)	lost due to inclei	nent weather.
RF Jordan & Coastal Drillin	Sons ng and Blasting	3.0 days 2.0 days	_ ·		
PROJECT ST	ATUS				
	Complete	Sched	duled Con	npletion Date	
	on schedule	or	days	/weeks ahead/be	ehind schedule
Based on the s	submitted schedule	e the project i	is getting	started later the	n what was originally

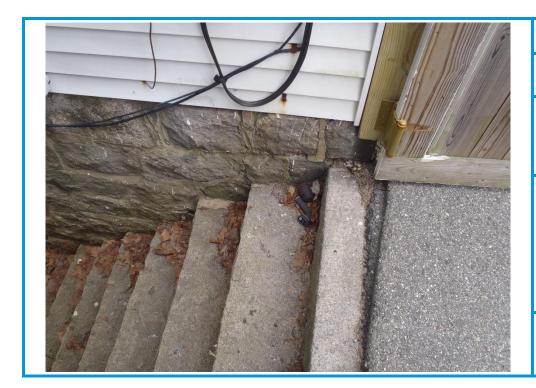
Photo No. 1

Granite Steps where utility service conduits will need to exit out through to the Kimball Shop

The underground electrical, telephone, and cable conduits that will supply the Kimball Shop will need to exit out through a set of granite steps. This will require more effort then simply excavating to a foundation and then backfilling the conduits.

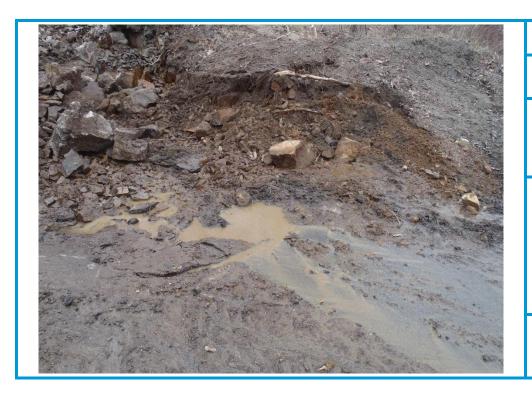
Photo No. 2

Water coming out of the ground after blasting in the north parking area

There appears to be some water in the blasted ledge in the north parking area which was released upon blasting. The parking lot subgrade will need to be evaluated to see if an underdrain system will be required to keep water from trapping in the parking lot subgrade and base.

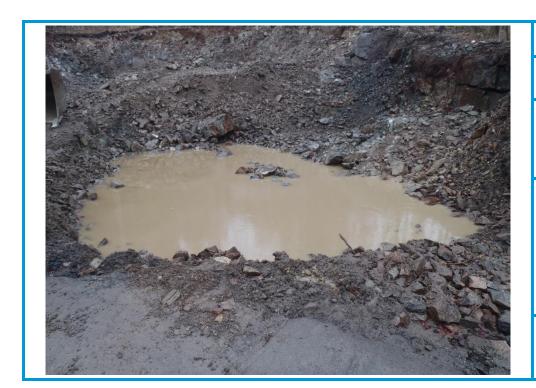
Photo No. 3

Ponded water in the north parking area after rock removal operations
