Report 06

WEEKLY CONSTRUCTION INSPECTION REPORT

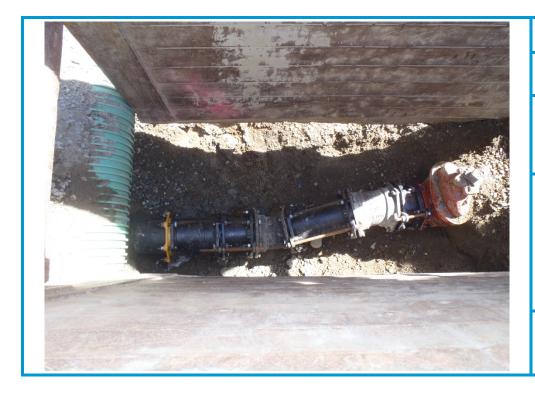
Photo No. 1

Water Main Connection into Sea Street

8 inch Main out of the Main Street valve drops into the Sea Street Main

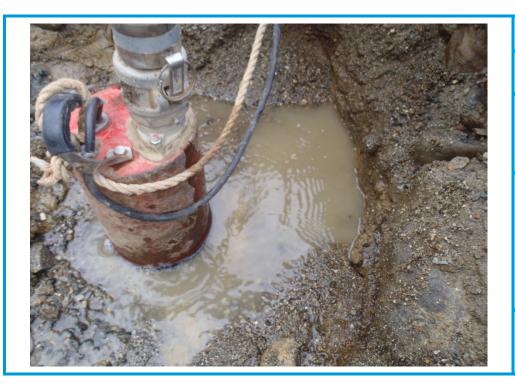
Photo No. 2

While installing the underdrain in the north parking area a 3-inch PVC line was discovered just in behind the existing catch basin in front of the north parking area which runs up along Harborside. No one has any knowledge of this line or where it goes. The location of this line appears to conflict with the proposed drainage system. We will look at this to determine if this line will need to be relocated for future construction of the drainage system this fall.

On Harborside Rd in behind the existing catch basin

3-inch unidentified PVC line which runs up along Harborside Rd, the line is just to the right of the pump in this picture

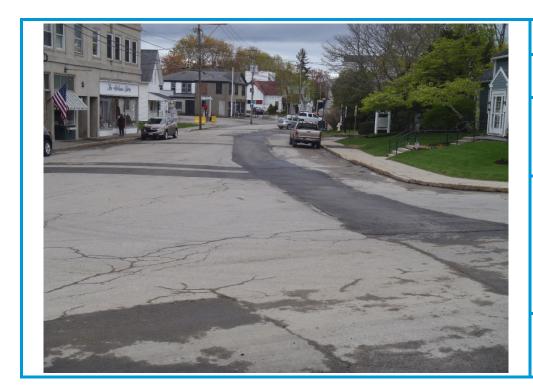
Photo No. 3

Site Location: Main Street

Description:Trenches were all paved in

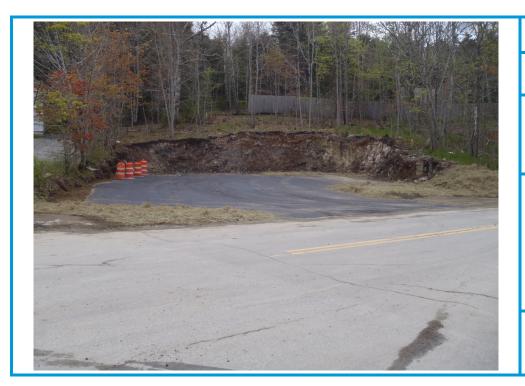
Photo No. 4

Site Location:North parking area

The north parking area was graveled and paved for the summer
