WEEKLY CONSTRUCTION INSPECTION REPORT

Report 03

Project: Northeast Harbor Center Village Improvements
 Location: Northeast Harbor
 Contractor: RF Jordan & Sons
 Client: Town of Mount Desert
 From: Victor J. Smith, P.E.
 To: Tony Smith, Director of Public Works

Date: 4/30/19

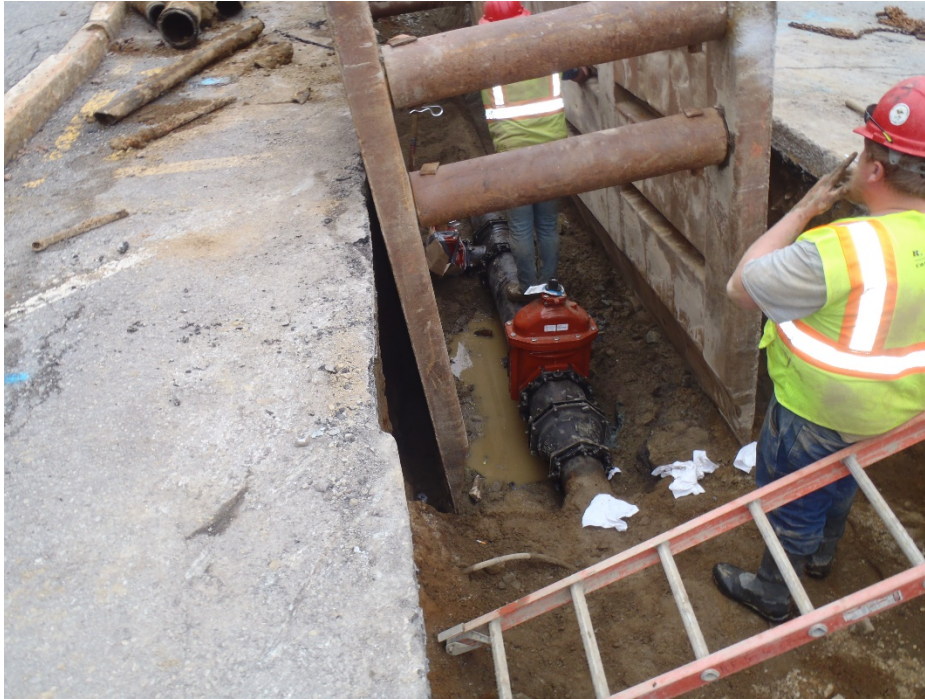
Photo No. 1

Description:
Tie in with gate valve
to the existing water
main on Main Street

Began Water Main installation with the new gate valve at Sta. 8+10 +/- on Main Street running towards Summit.

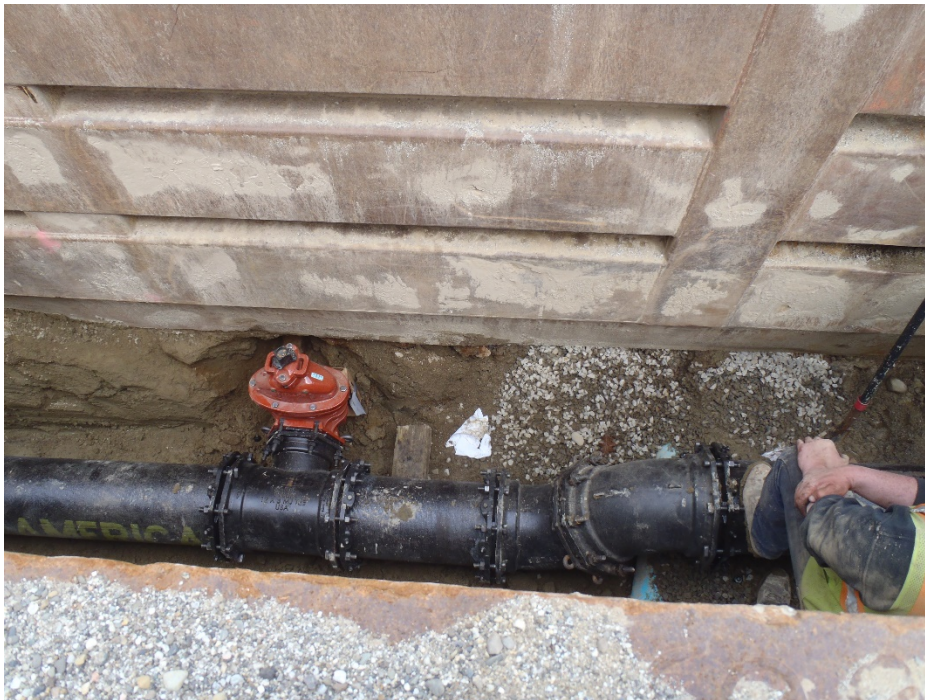
Photo No. 2

A 4-inch PVC perimeter drain extending into the street has caused us to reroute the new water line under it to allow it to be reconnected. This perimeter drain was not on the plans and was an unknown until it was uncovered. The water line was dropped approximately 11 inches at this location to allow the drain to be reconnected. This may require that the water line may need to be chased down Sea Street a little farther than expected to prevent a high spot in the water line which may trap air.

Description:
Water line elevation
drop to go over
sewer and under the
4-inch perimeter
drain

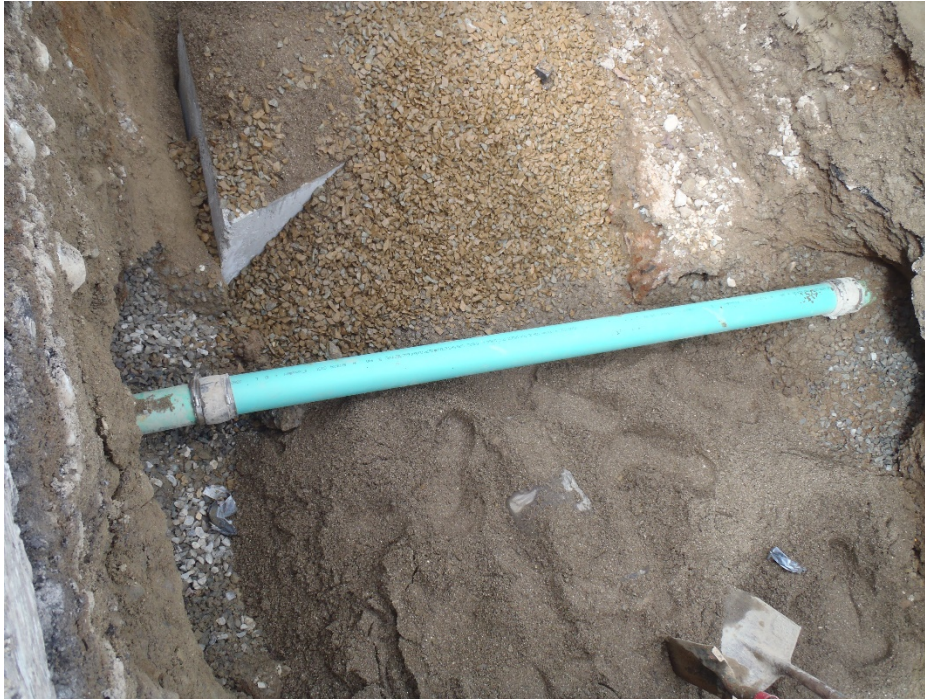
Photo No. 3

Description:
4-inch drain line
reconnected over the
water line

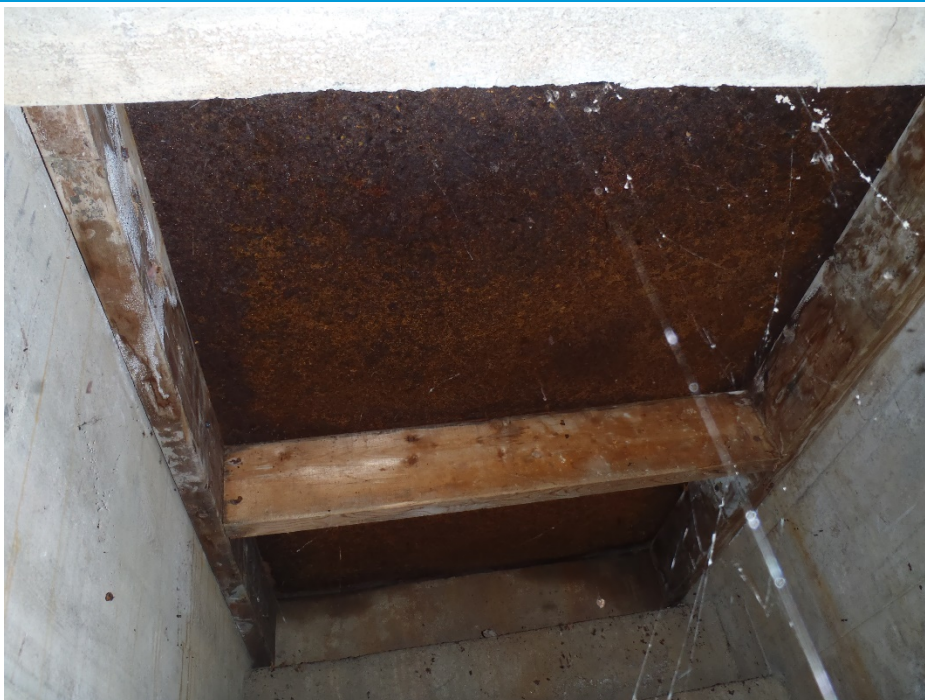
Photo No. 4

There appear to be covered openings under the sidewalk in front of some of the buildings in town. The sidewalk was built over an opening into the basement of the Post Office building. I will be checking other buildings as time and opportunity exists to determine if any more of these situations are out there. This one is in addition to the known hollow sidewalk down at the vacant lot beside the Kimball Shop..

Description:
Covered bilco under
the sidewalk in front
of the Post Office
